# Assessment of Dam Safety

## Coal Combustion Surface Impoundments (Task 3)

Pleasants Power Station

McElroys Run Dam

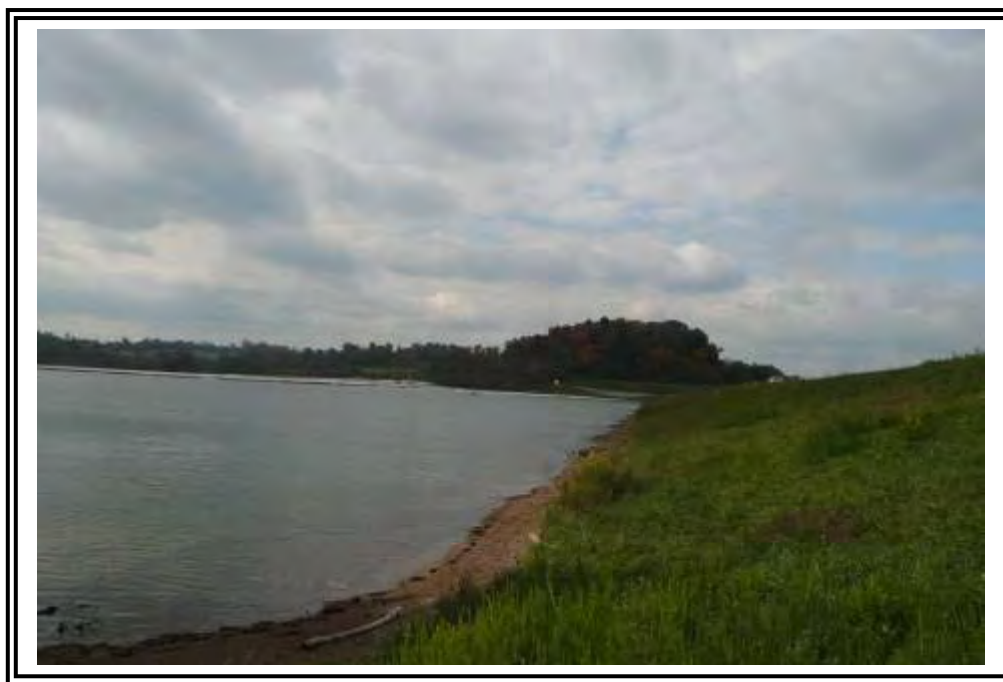
4

Looking west along the upstream slope face.  
Note exposed soil below grass line where water level has been lowered.

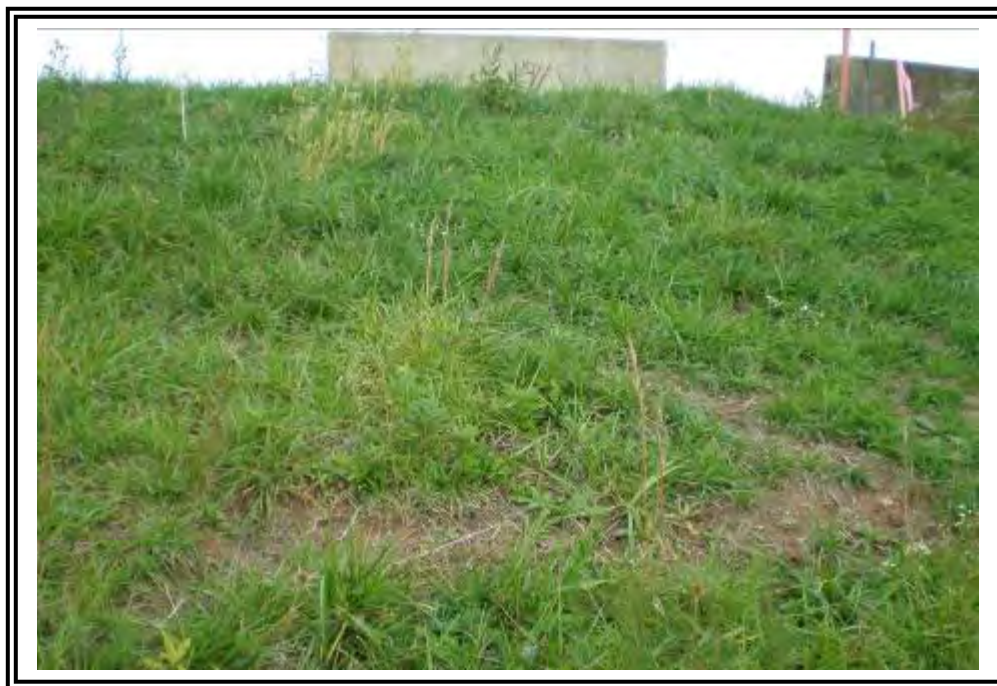
9

Exposed soil at possible tire rut or surface erosion area on upstream slope.

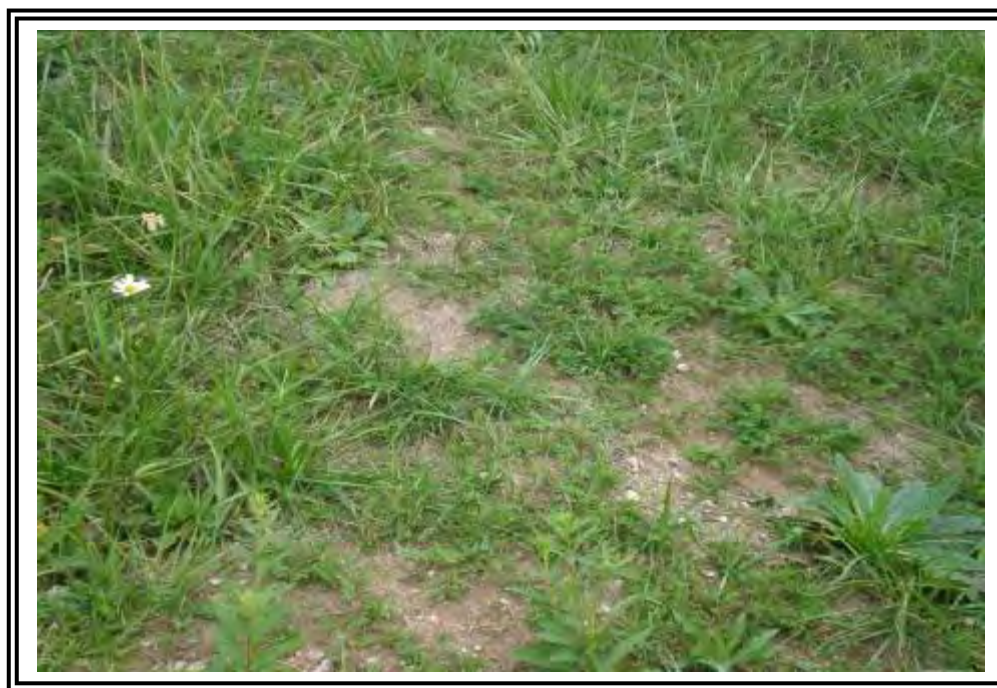
10

Loss of ground cover and erosion on upstream slope.

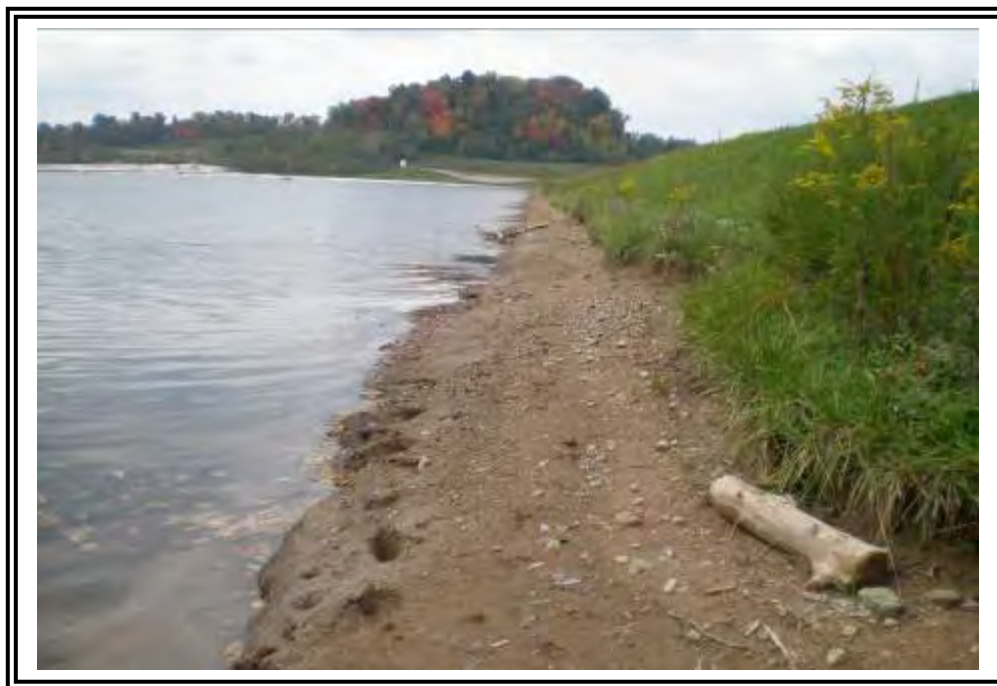
11

Looking southwest along upstream slope at water level. Note beaching erosion at both former water line and current water line.

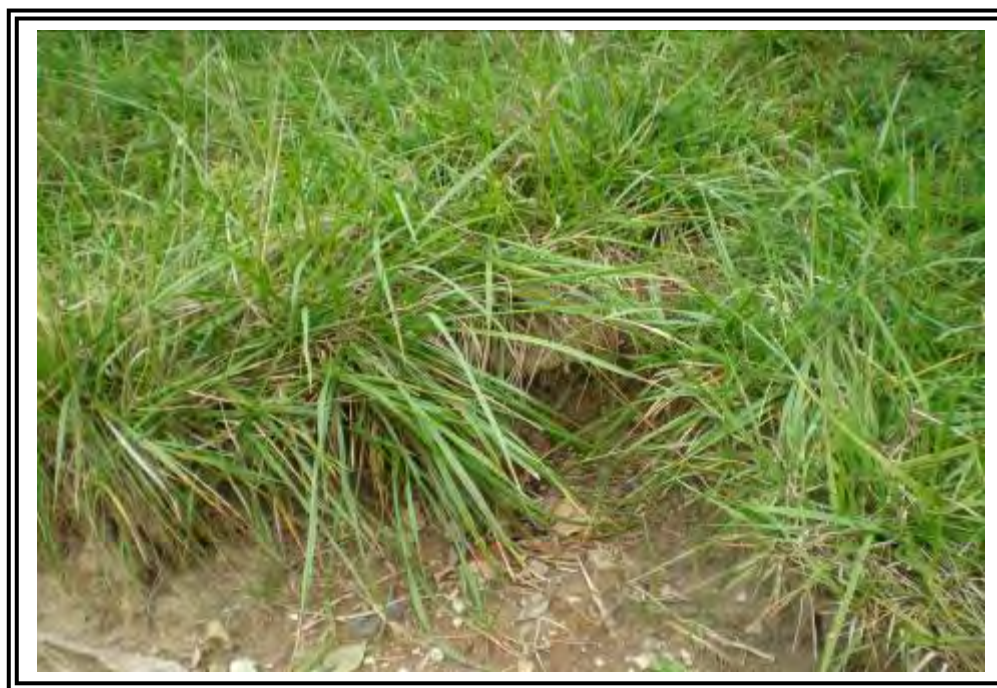
12

Close up of beaching erosion on upstream slope.

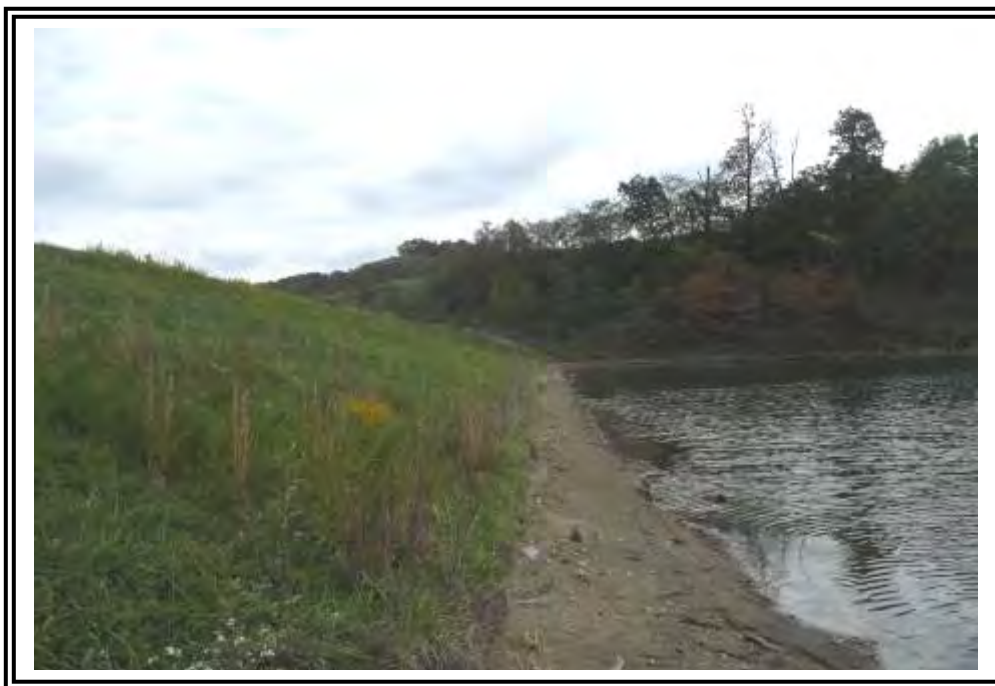
13

Looking east along upstream slope face with another view of the soil exposed below the grass line.

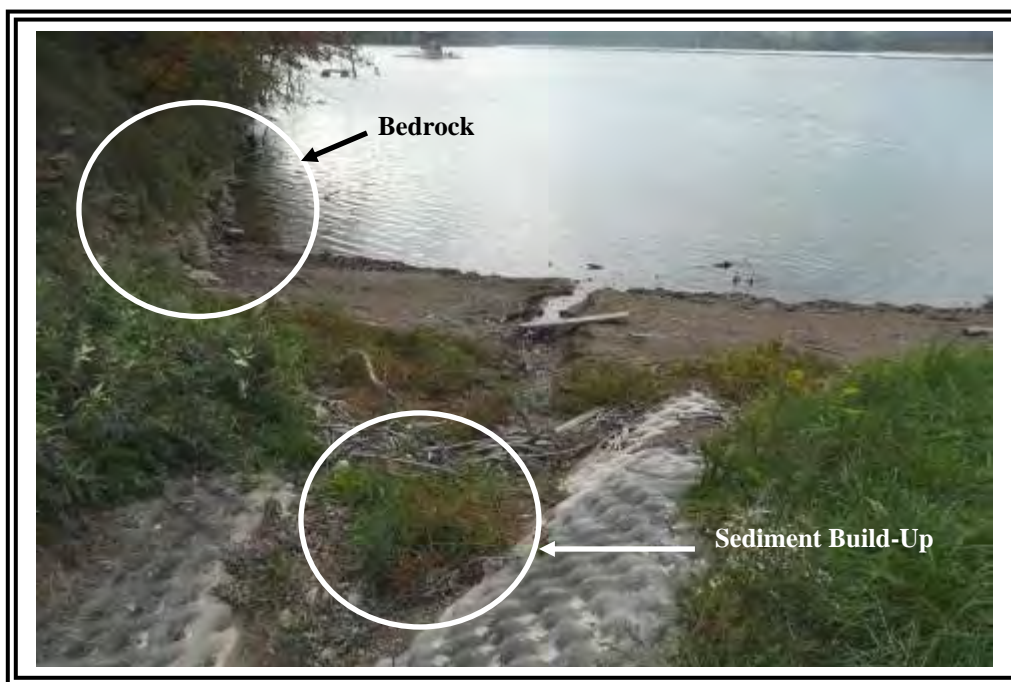
16

Upstream slope right abutment groin looking toward toe and lake.  
Note sediment build-up near end of groin and bedrock exposed to the left of the groin

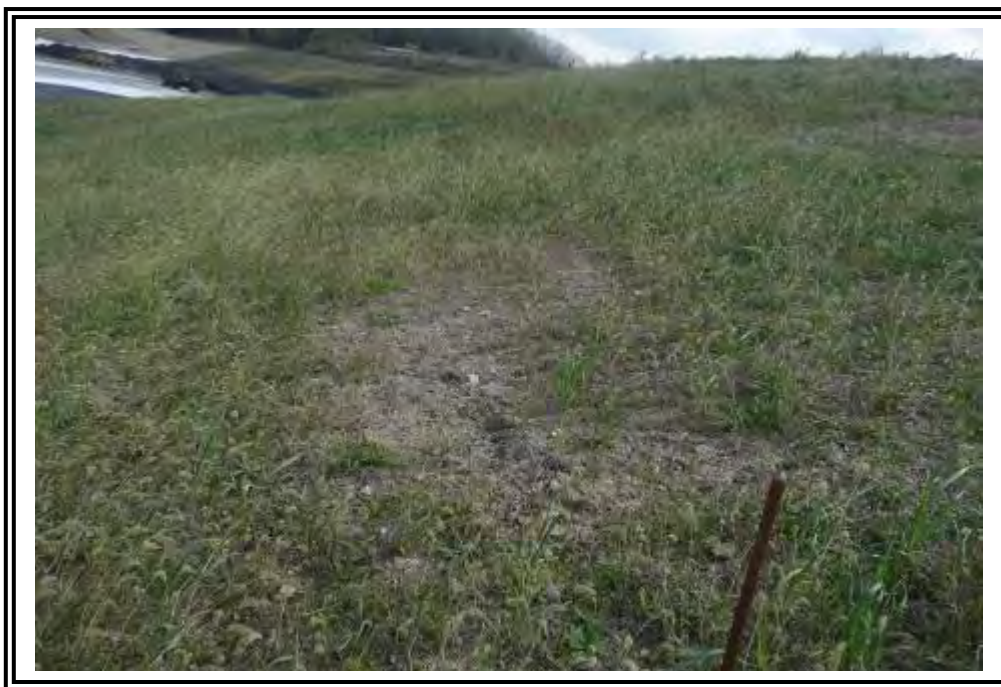
23

Close-up of thinning and lost grass cover area on downstream slope.

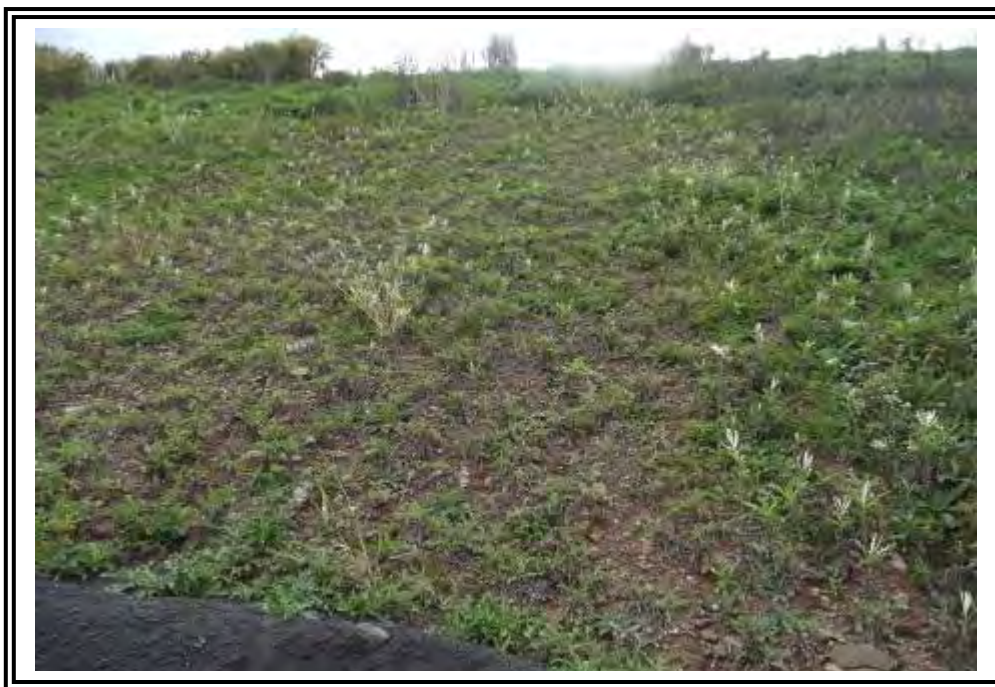
25

Another area of thinning grass cover and potential erosion above bottom ash drainage blanket.

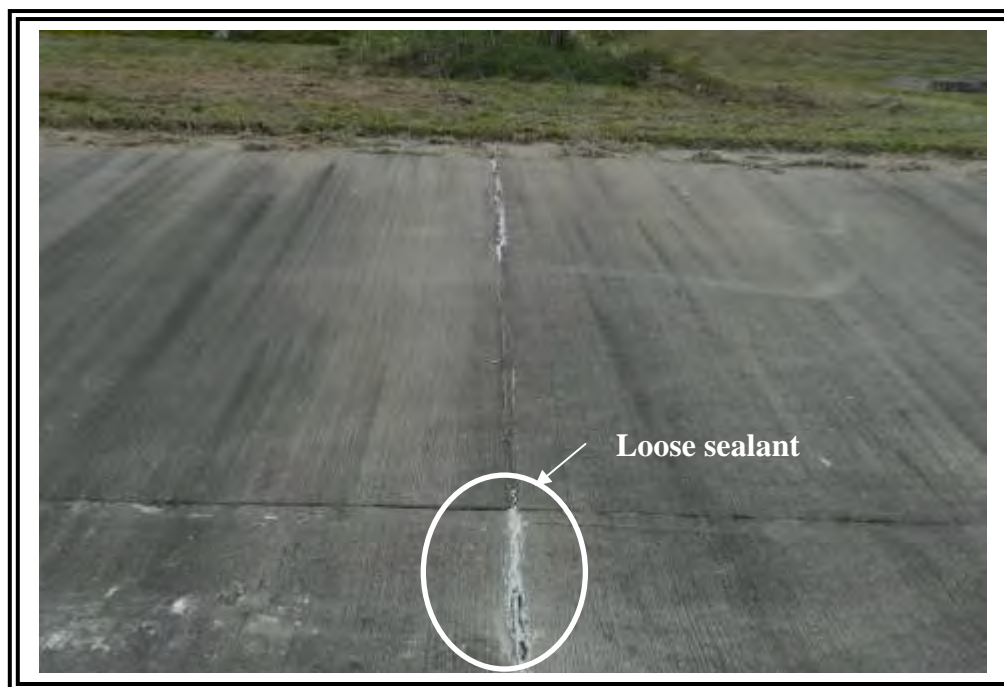
33

To the west of the dam there is a concrete emergency spillway as shown in Photos 31 through 35. The approach to the concrete paving is lined with stone rip rap (Photo 31), and there is grouted riprap protection at the outlet of the emergency spillway as shown in Photo 35. Loose caulk was noted at some of the joints between concrete paving panels as shown in Photo 33.

Expansion and crack control joints in concrete spillway. Note loose sealant in joints.

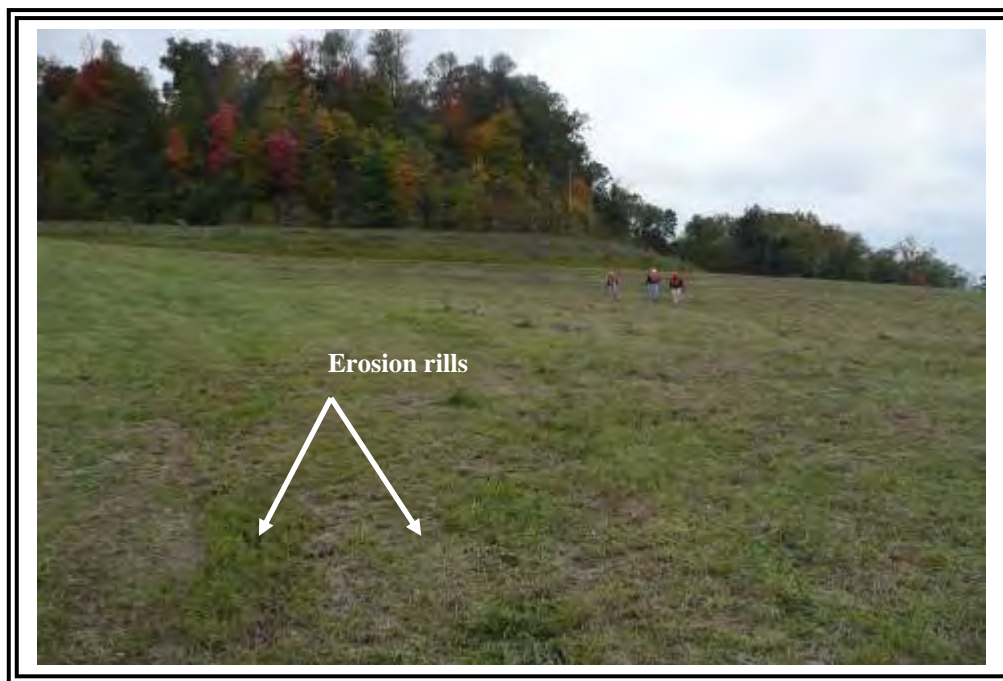
36

Looking west at downstream slope below emergency spillway. Grassed erosion rills (slightly darker green areas in grass cover) can be seen in this area.

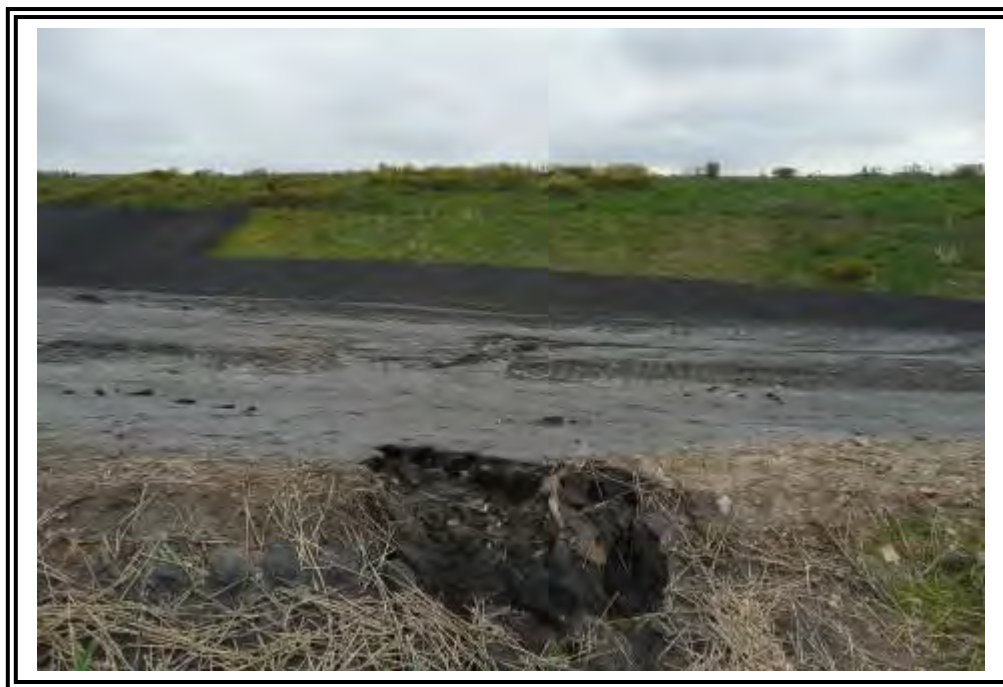
Landfill benches below the bench currently under construction are grass covered with occasional isolated woody vegetation. Occasional loss of grass cover and rutting from mowing equipment, and occasional active and repaired rodent burrows were observed. There were some deep (6 to 10 inches) erosion rills in the area where recent re-grading for the recently constructed access road has occurred on the east side and in the recently placed bottom ash blanket drain as shown in Photos 37 and 26, respectively.

Erosion rill in fly ash at edge of active bench in the buttress landfill.  
Downstream slope of the actual embankment dam visible in distant background.

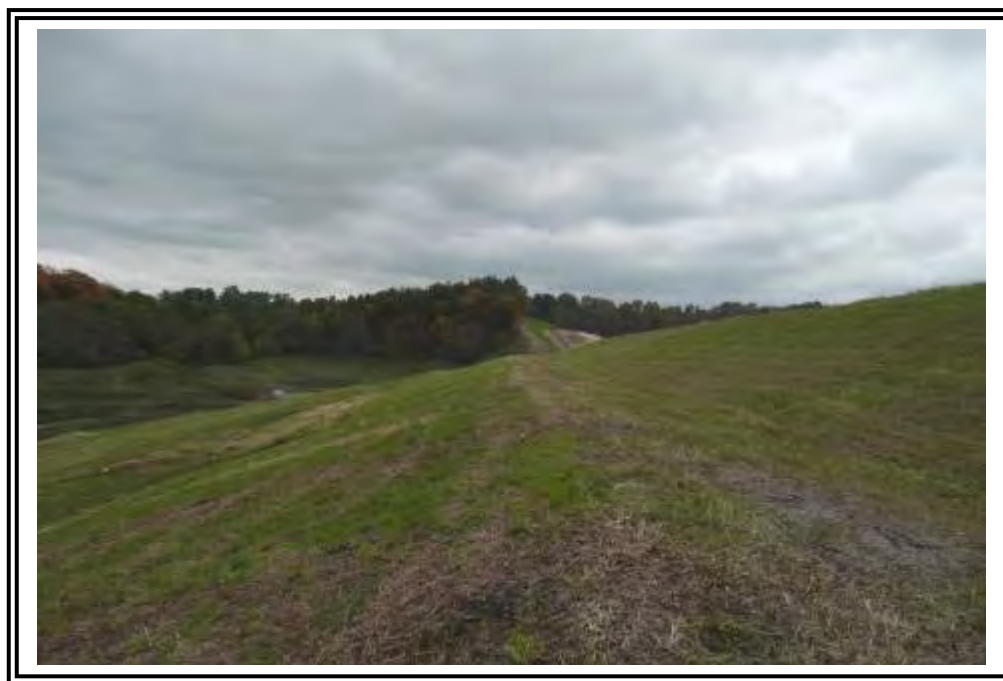
38

Looking northeast from right abutment contact along the downstream slope of the buttress landfill. Note water deposited ash from working bench above this level.

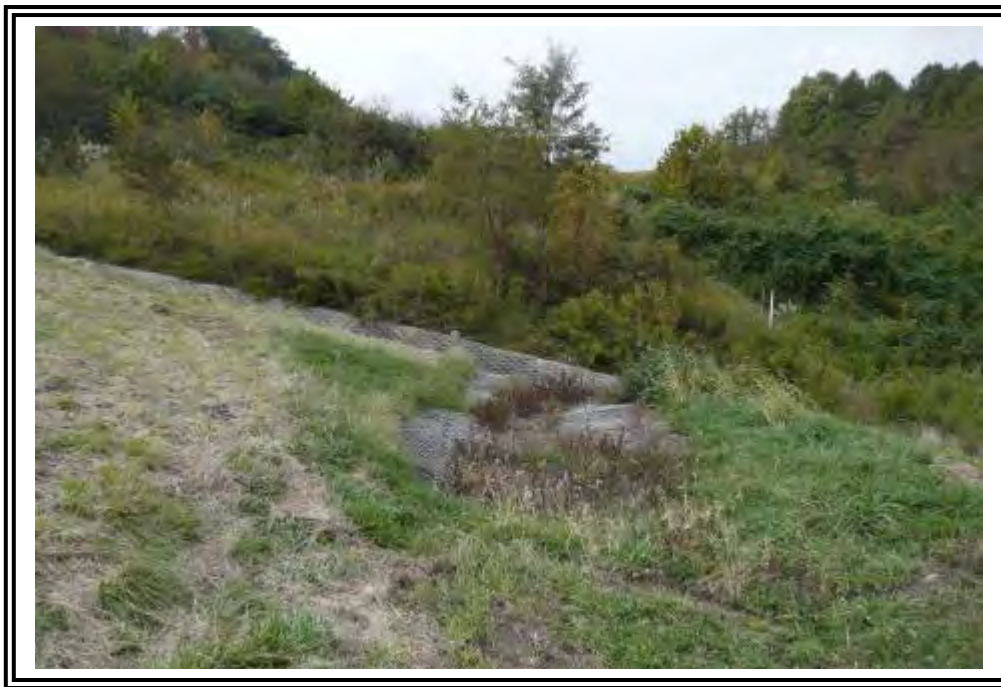
39

Fabric formed concrete lined tie-in from bench (Bench H) to left abutment groin.  
Note vegetation beginning to become established in sediment deposited in ditch over time.

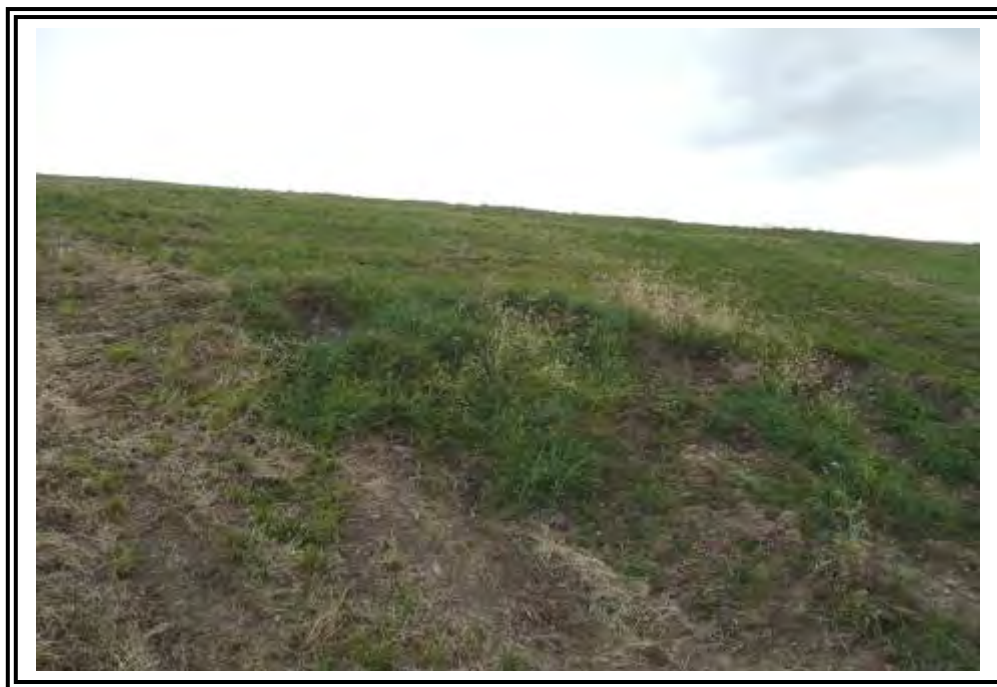
41

Slope disturbance due to mowing activity and subsequent erosion, exposing ash beneath soil cover.

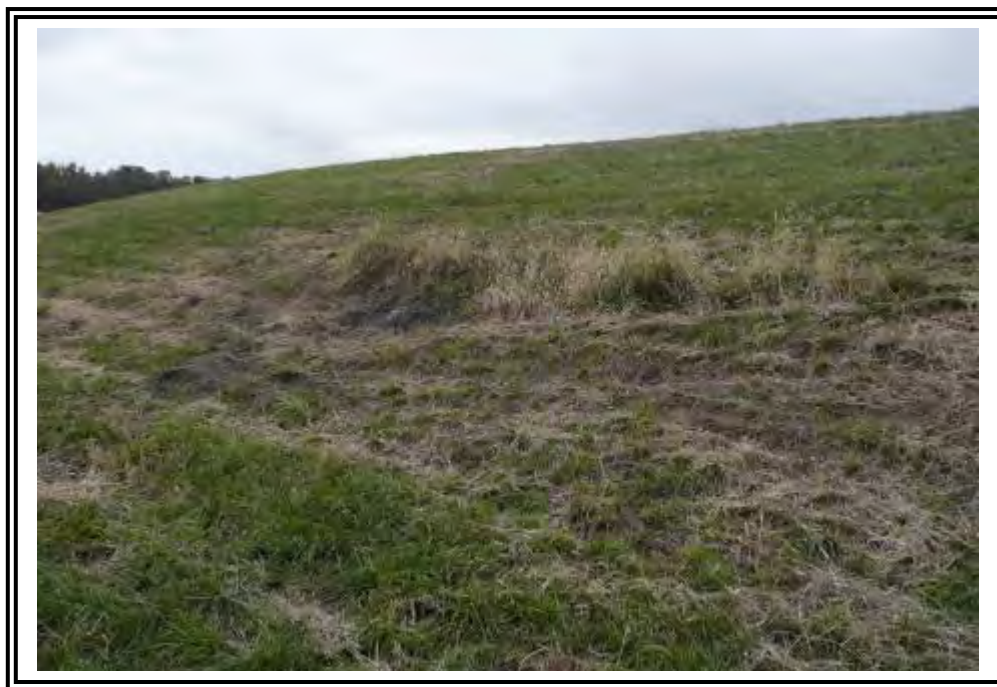
43

Another area of slope disturbance, erosion, and exposed ash due to mowing equipment.

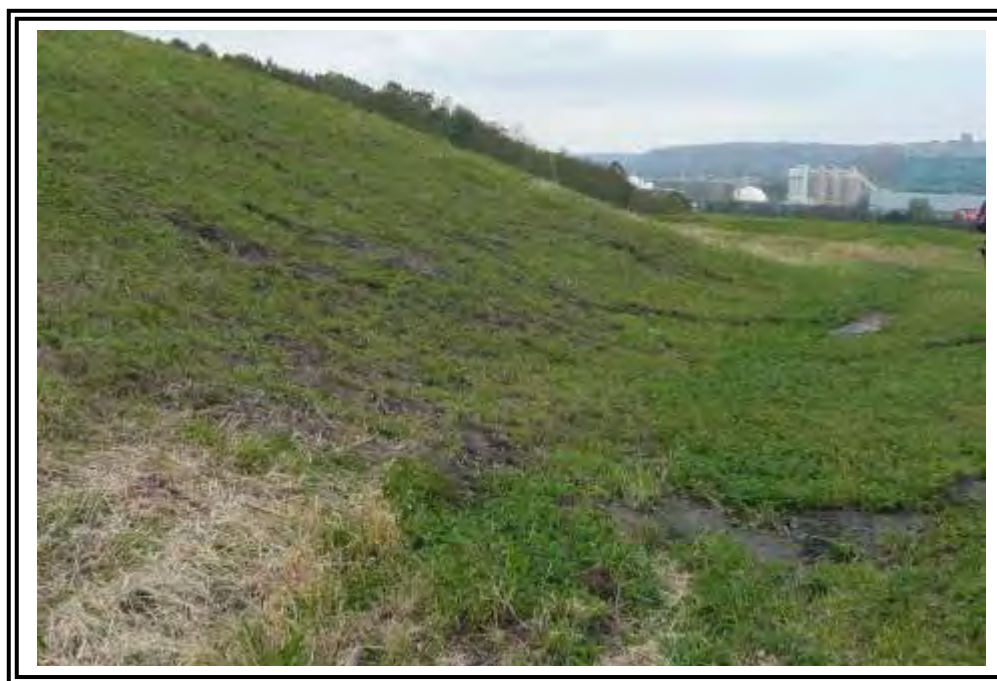
44

Erosion rills in exposed ash where soil cover was too thin or ash was transported via sheet flow from the active working bench above this area.

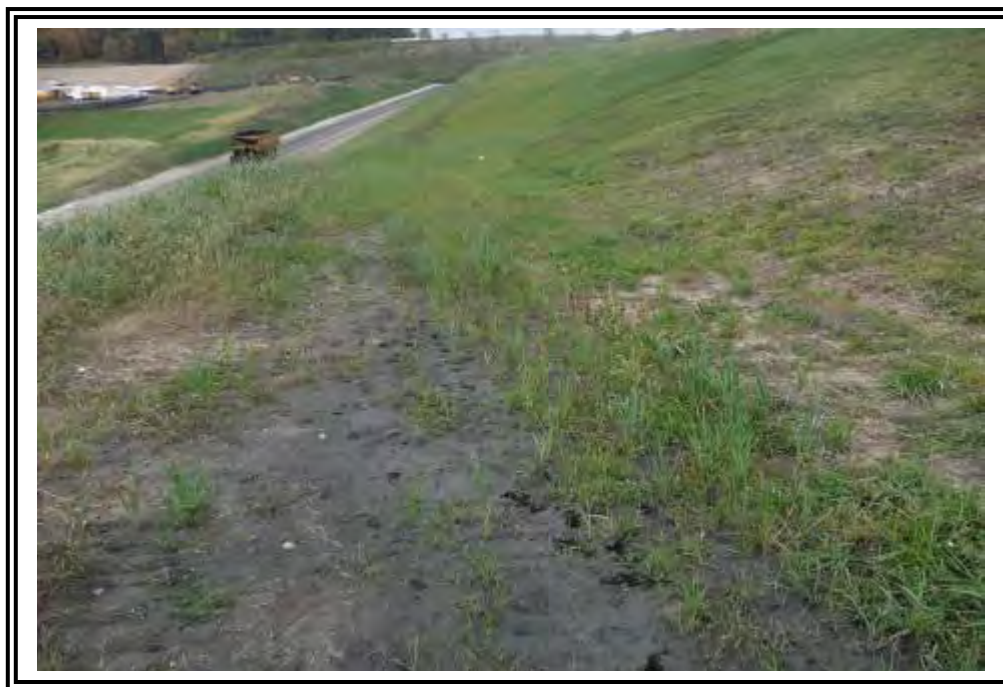
45

Water deposited ash and loss of grass cover on inactive bench and slope.

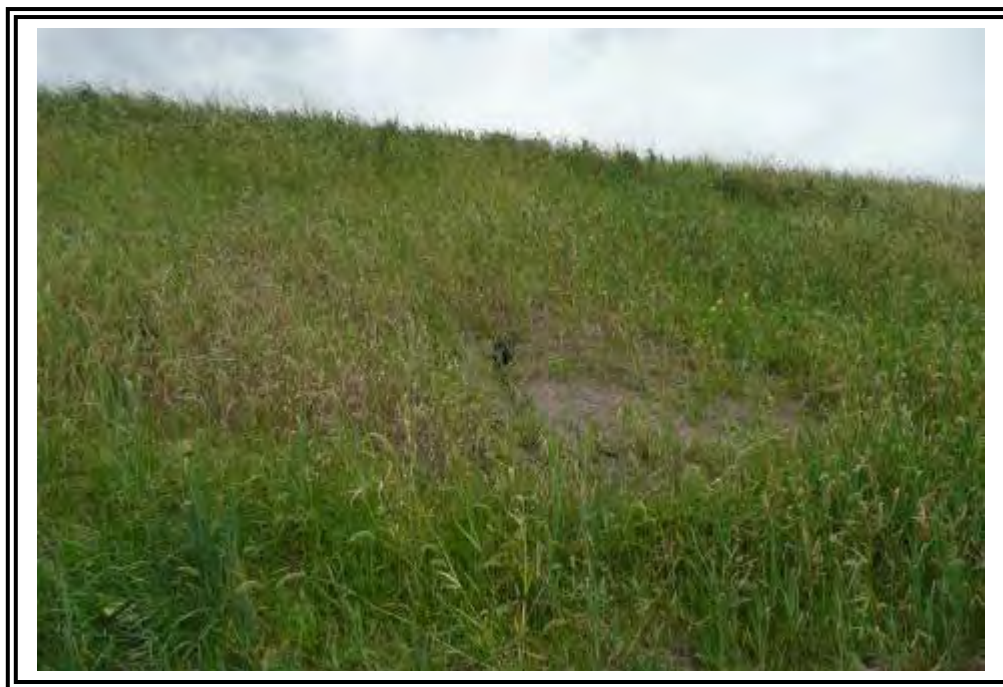
47

Erosion rill and loss of grass cover on landfill buttress slope facing haul road.

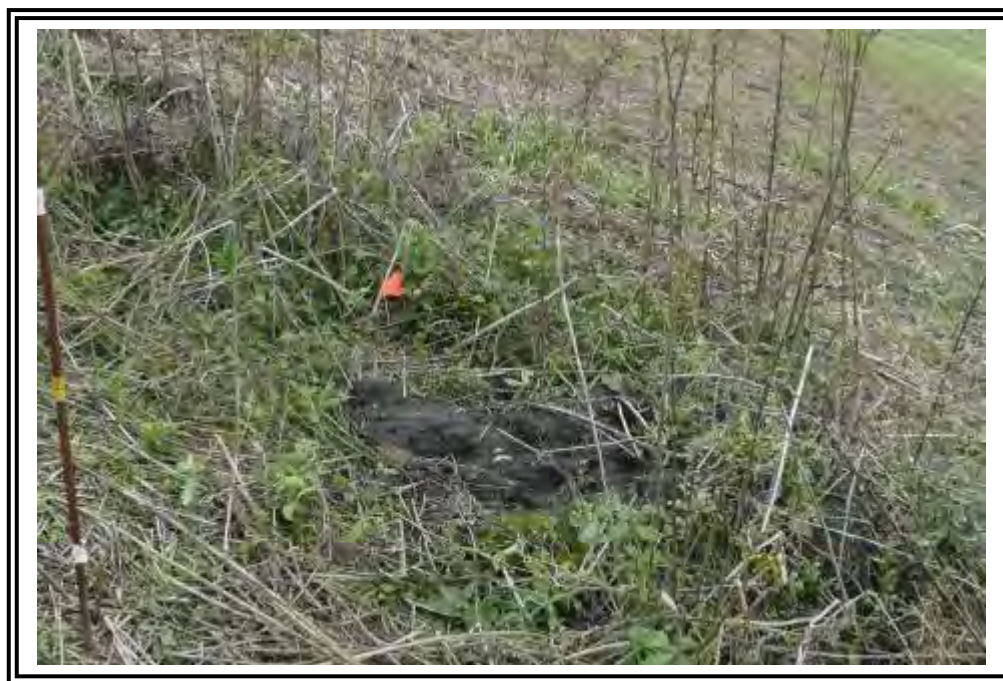
48

Repaired rodent burrow on landfill buttress slope.

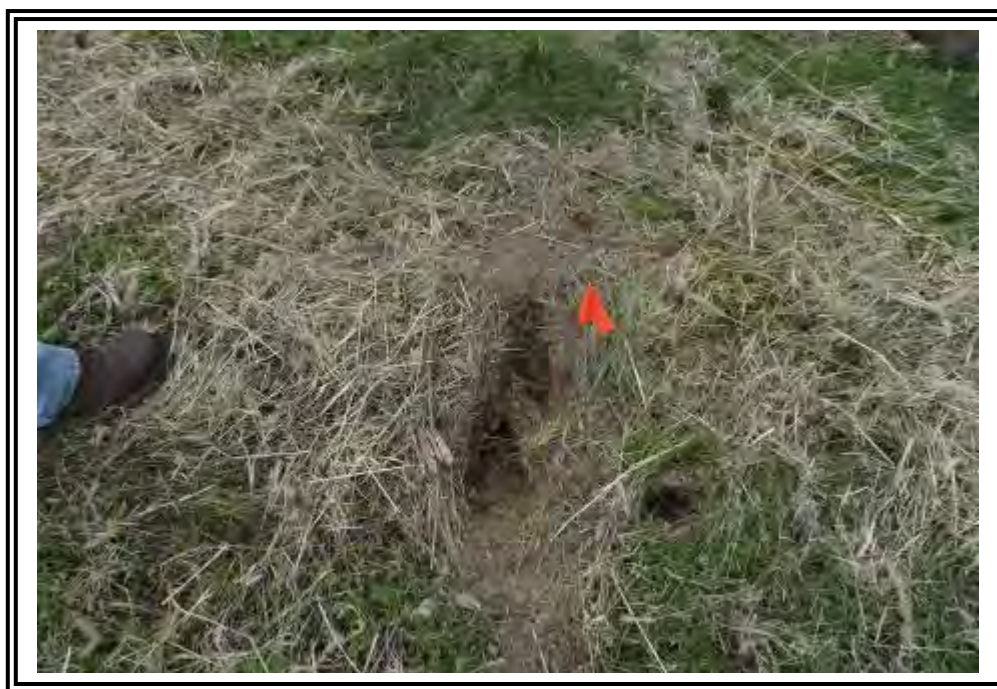
49

Collapsed more recent rodent burrow area

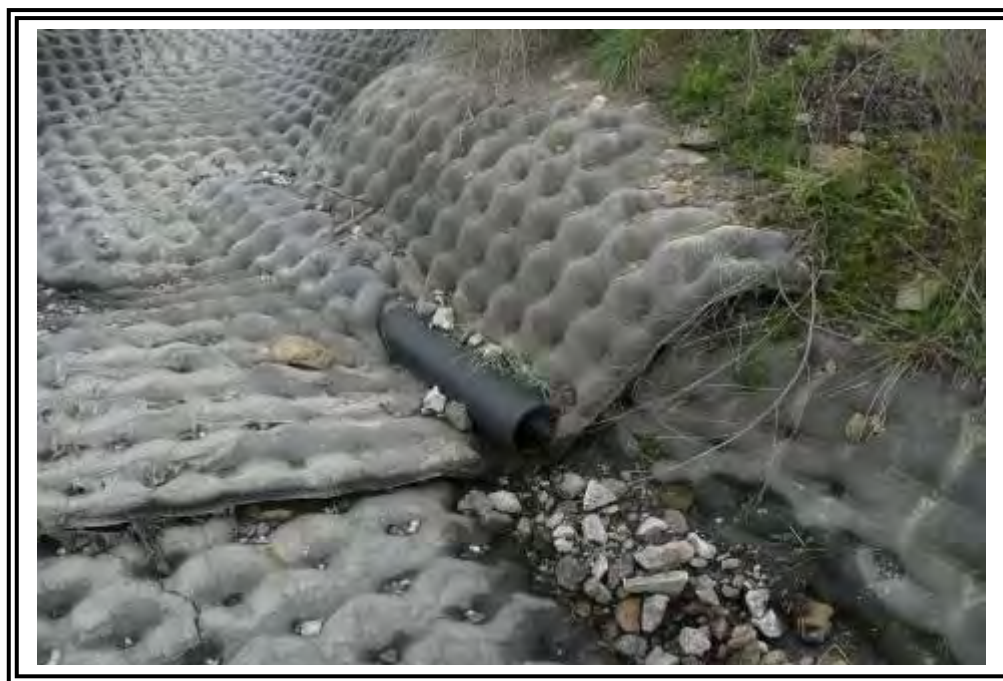
52

6" diameter abutment drain outlet to west (left) abutment groin below active bench; seepage clear. Groin dry above this level.

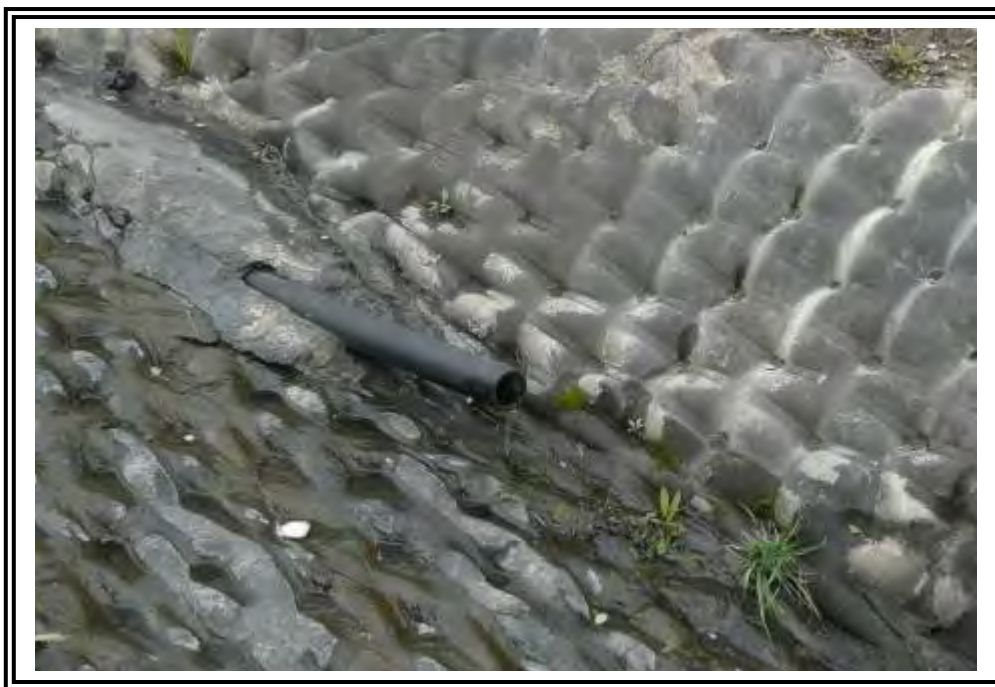
53

Seepage pipe outlet to groin around Bench E in west groin; seepage clear.

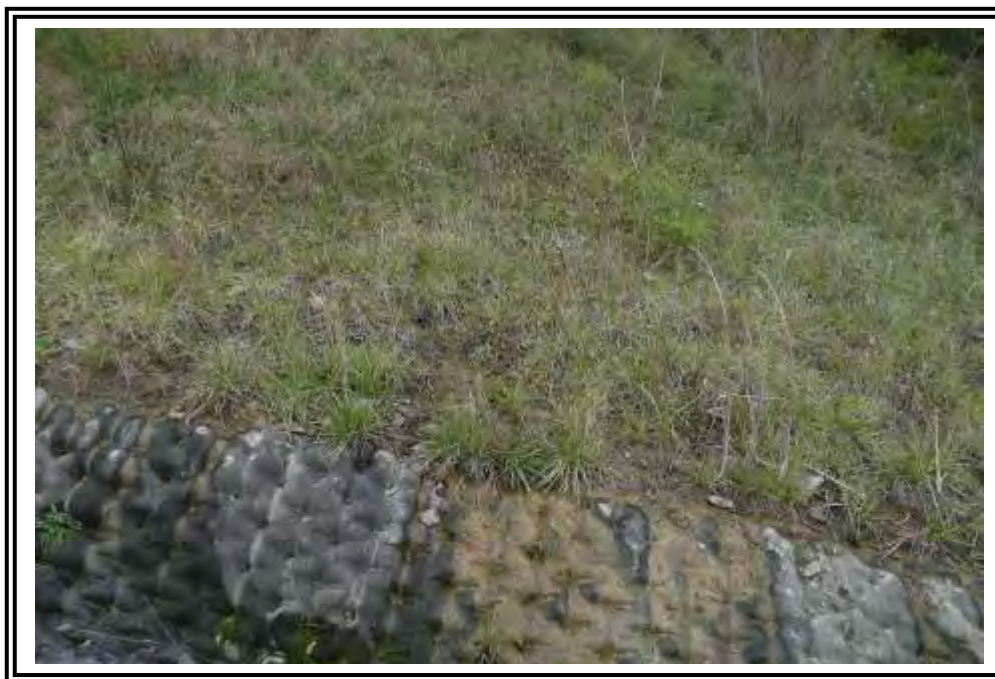
54

Seepage from hillside near area of hillside slide repair.

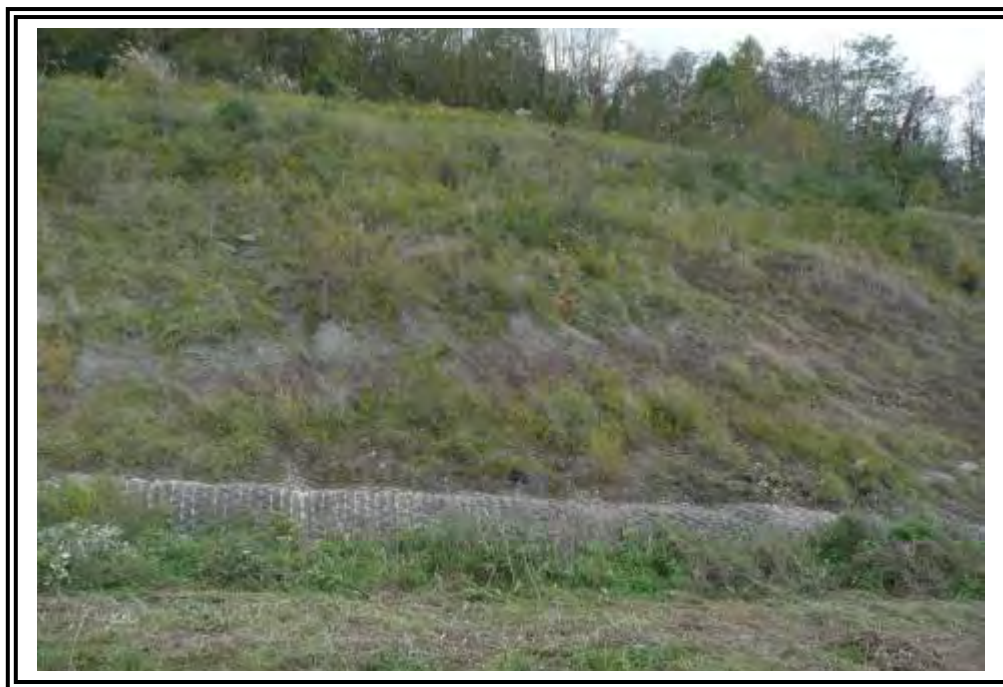
55

Red bed shale residuum exposure in hillside at west (left) buttress landfill abutment contact where hillside slide was repaired.

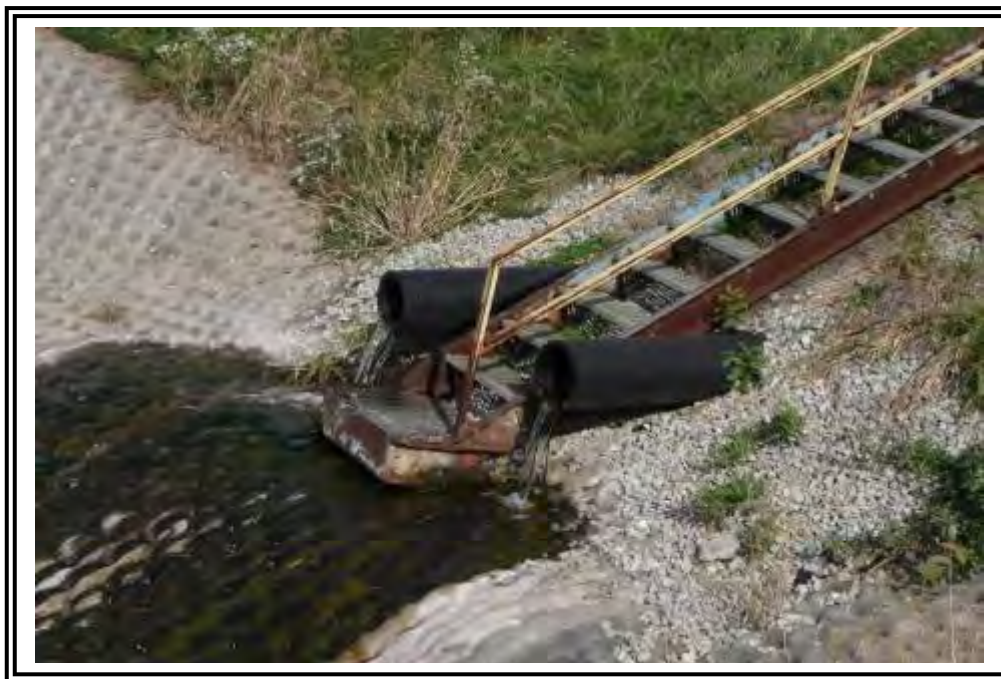
58

Blanket drain seepage collection system outlet. Approximately 36 gallons per minute. Seepage was clear.
